NASA Technical Memorandum

NASA TM - 82552

IN-HOUSE WELDING STUDIES SUPPORTING THE PRELAUNCH ASSESSMENT OF THE STS-6 MAIN ENGINES

By Lisa L. Hawkins

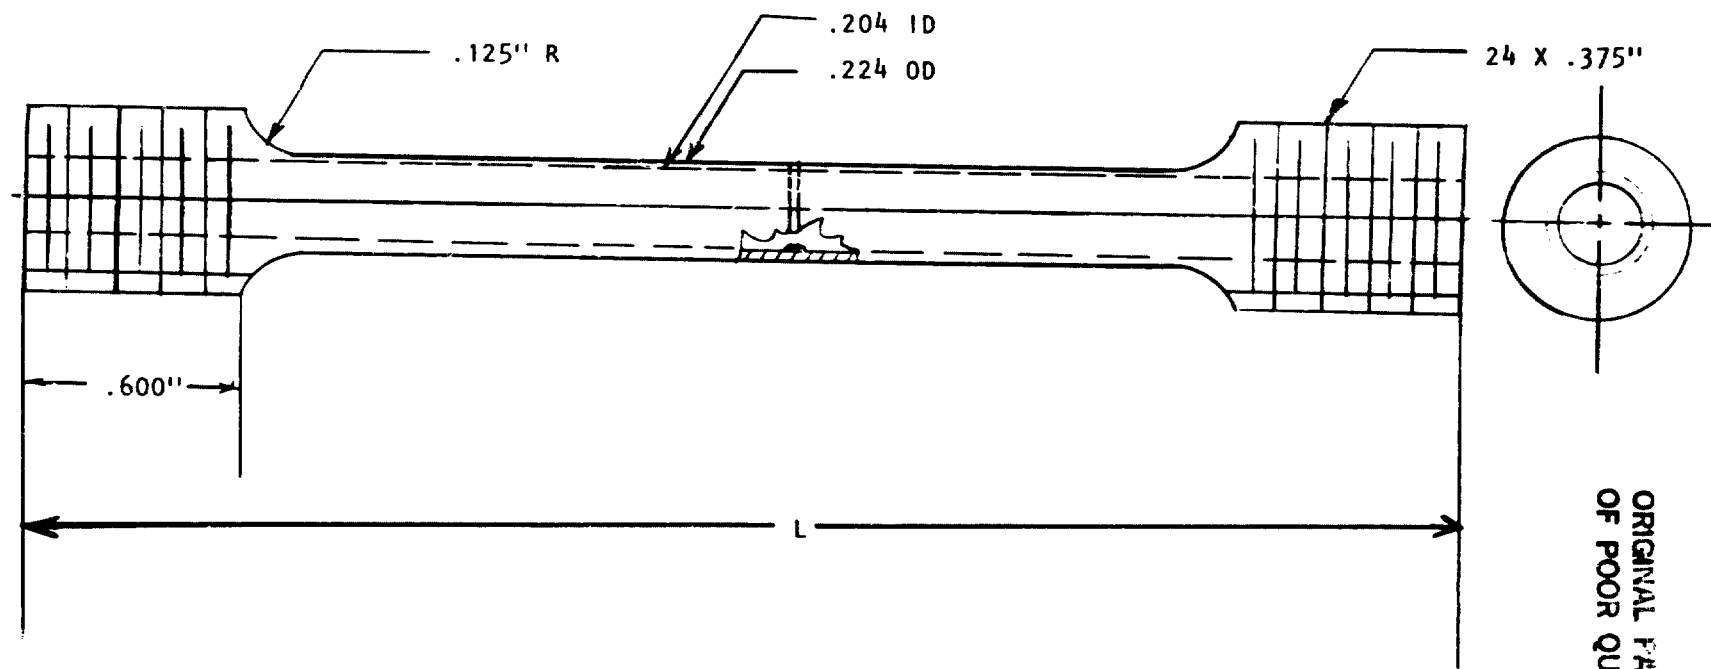
Figure 1. Specimen configuration.

The leak in the heat exchanger of Challenger engine 2016 stimulated program-wide examinations. Since the heat exchanger was known to fail due to lack of fusion in a weld, the welding procedures were of particular interest. Metals Processes Branch at MSFC fabricated several test specimens which closely represent the heat exchanger coil. Tubes of 316 stainless steel and Haynes 188 alloy were joined together with a filler insert. The configurations of the test specimens and the filler insert are shown in Figures 1 and 2, respectively. Figure 3 shows the initial components, and Figure 4 shows a completed specimen.

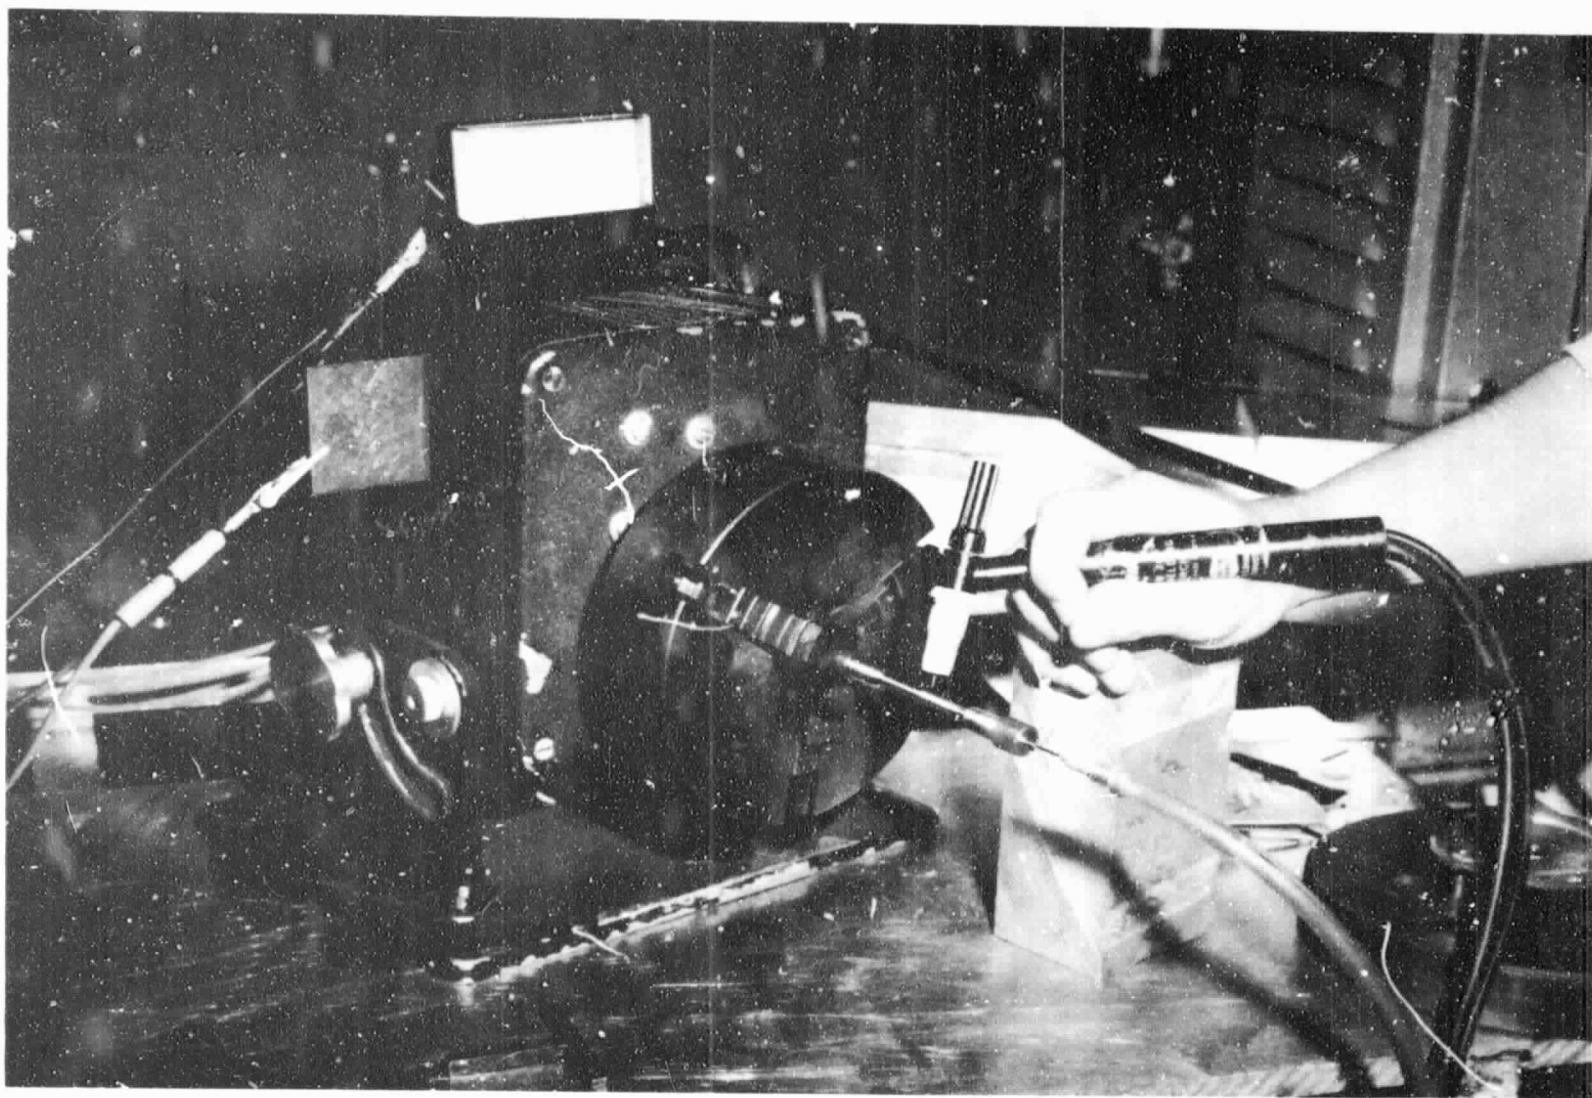
Figure 5. Weld station set-up.

The welding system set-up is shown in Figure 5. The fixture and welding positioner proved to be very important in providing the necessary accessibility and controlled travel speed. Because the amperage used to weld was very low (3 to 4 amps), a sensitive ammeter was required to effectively record it. A helium flow meter was calibrated for determination of the argon shield gas flow (Figure 6), because an argon flow meter capable of measuring small flow rates was unavailable. The purge and back-up gas was fed into the inside diameter (ID) by means of an injector needle which acted as a sliding bearing to avoid tangling the gas lines. Finally, the welder used a "hand prop" to hold the torch steady along the seam of the joint.

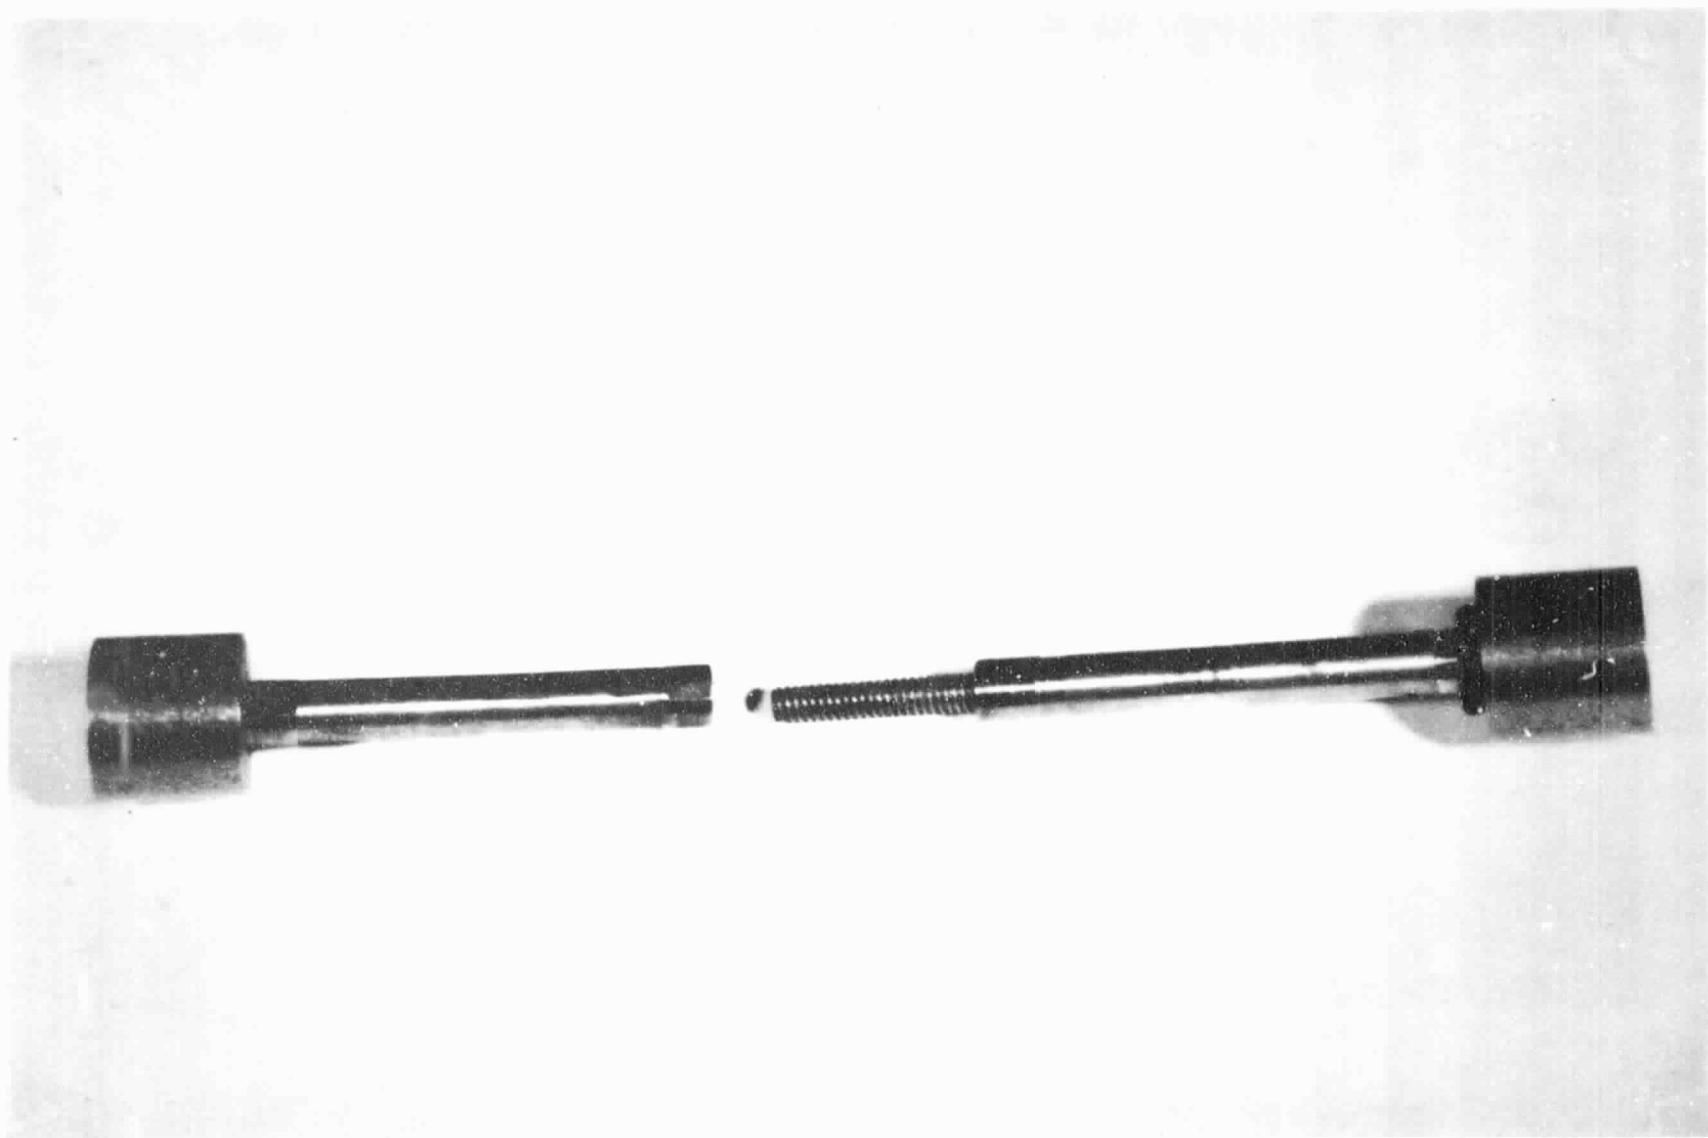
Figure 9. Weld fixture.

The fixture was necessary to hold the parts in place and to provide proper fit-up of the joint. Improper fixturing was suspected to be responsible for thin spots. The welds of the parent materials. Improper fit-up caused a portion of the tube wall to be removed in the post-weld reaming operation. Due to lack of sufficient data points, MSFC is unable to recommend an alternative to reaming at this time. Investigation into improved fixturing should be undertaken.

The welding positioner provided needed accessibility by allowing the operator to rotate the assembly at a controlled speed. Figures 9 through 11, respectively, show the fixture, the fixture-tube assembly, and the entire assembly in place on the fixture.

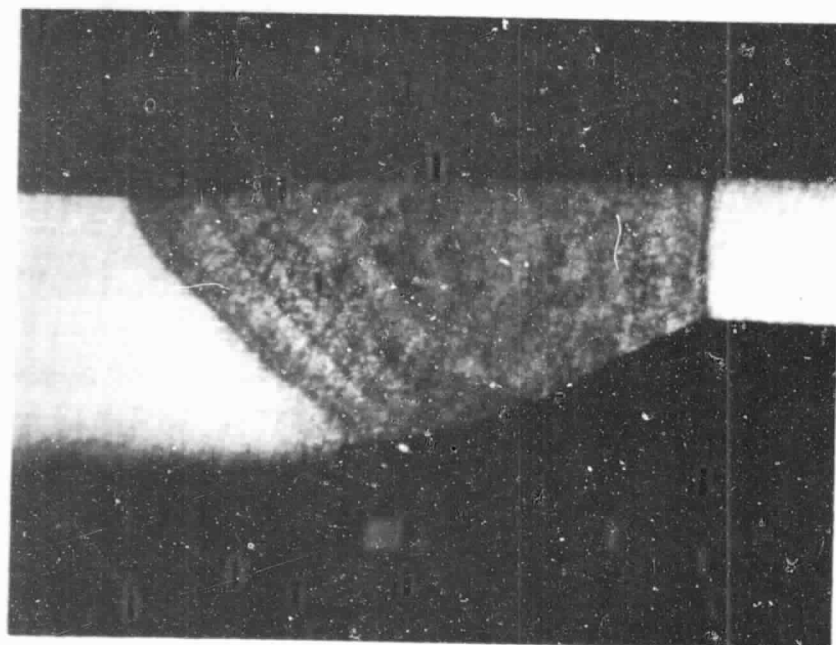
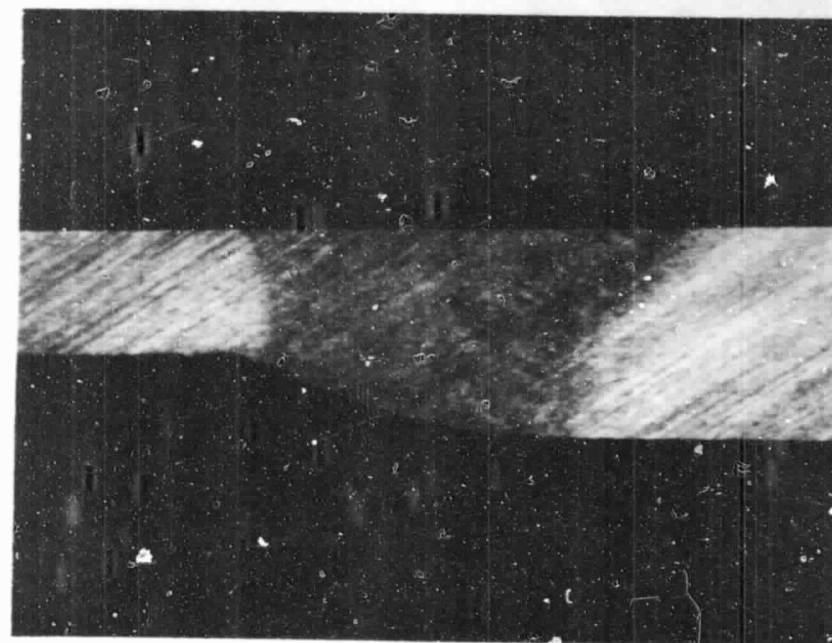
Figure 15. Radiography: weld 56.

Figure 14 summarizes the results of all the tests conducted at MSFC. Rocketdyne's "as-welded" allowable ultimate tensile strength is 102 Ksi. Note that the ultimate strength of the specimens was fairly consistent with percent penetration. Fatigue strength is expected to follow the same pattern. Figures 15 through 18 are included for reference.
